# AMC2

## Controllers and extension boards

### Misalignment of laser marking on certain connectors

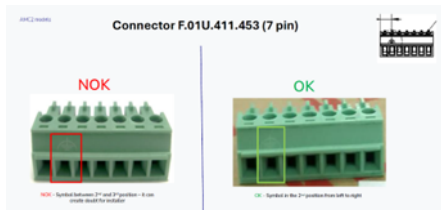
Figure 1.1: 7-pin connector

Typically, affected connectors show an unclear position of the earth ground symbol
