# RADION receiver SD

B810

These Release Notes are for the RADION receiver SD with firmware version 3.01.001.

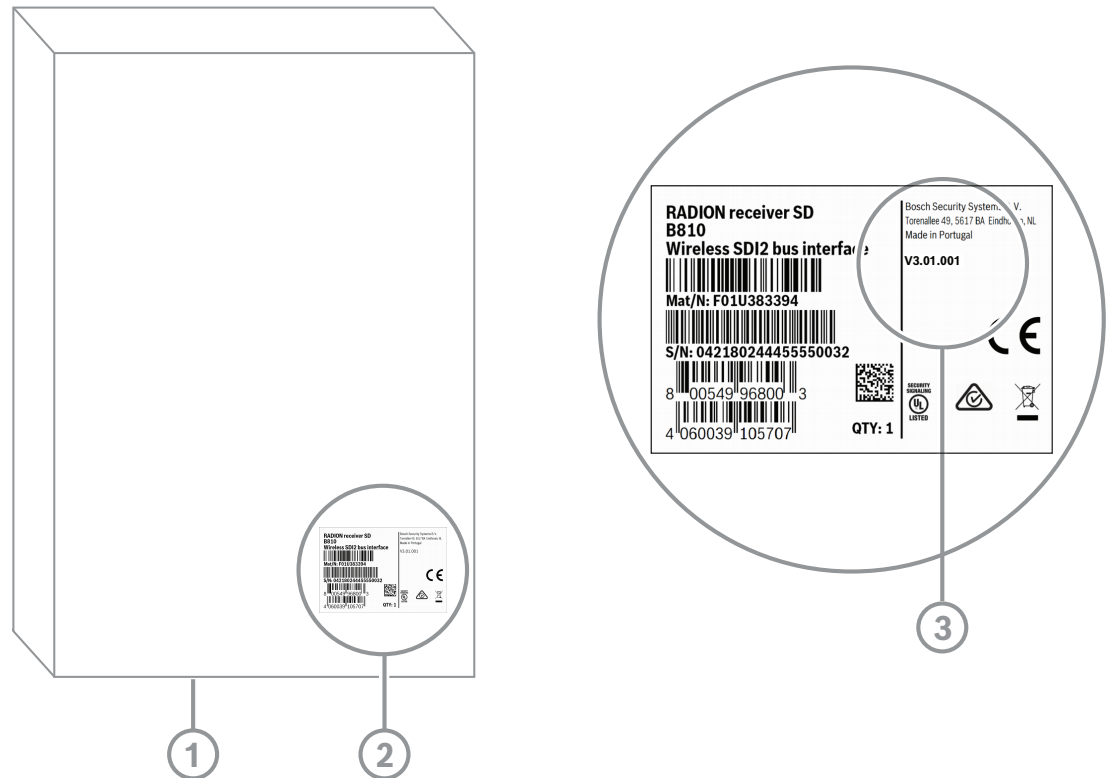
Figure 5.1: B810 box label and firmware version

| Callout - Description |
|---|
| 2 - Receiver box label |
| 3 - Receiver firmware version |

The B810 receiver and its packaging labels indicate the factory-programmed firmware version. This may differ from the version currently running if a firmware update has been applied in the field. To verify the currently running firmware version, use RPS diagnostics. RPS diagnostics also reports the receiver’s hardware revision level, which may be required for troubleshooting or compatibility checks.

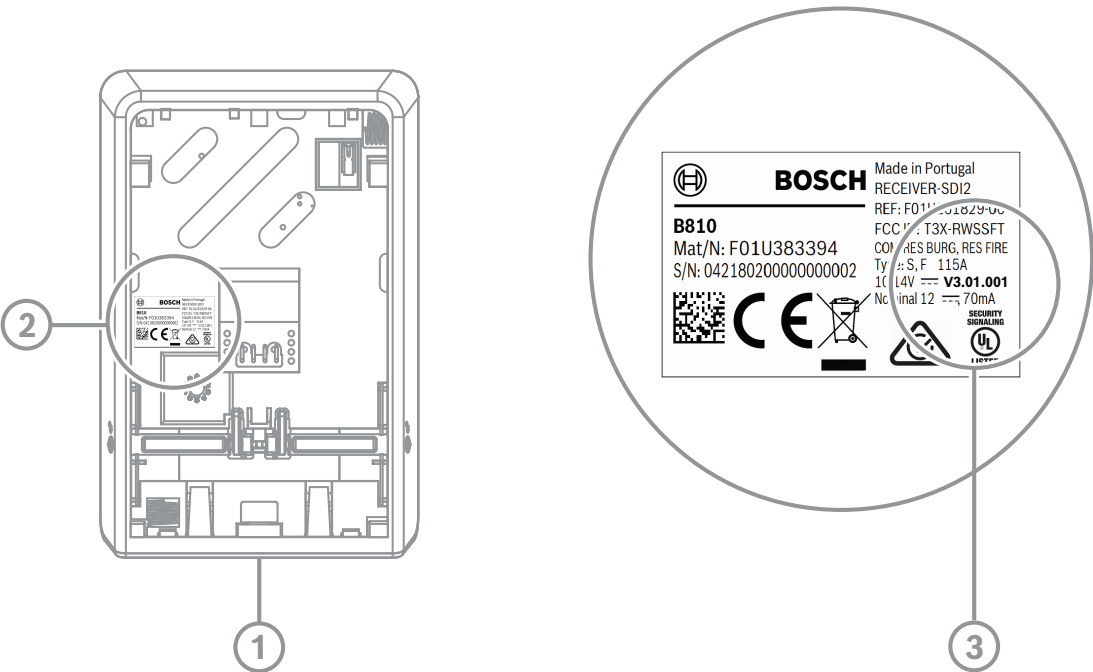
Figure 5.2: Receiver label

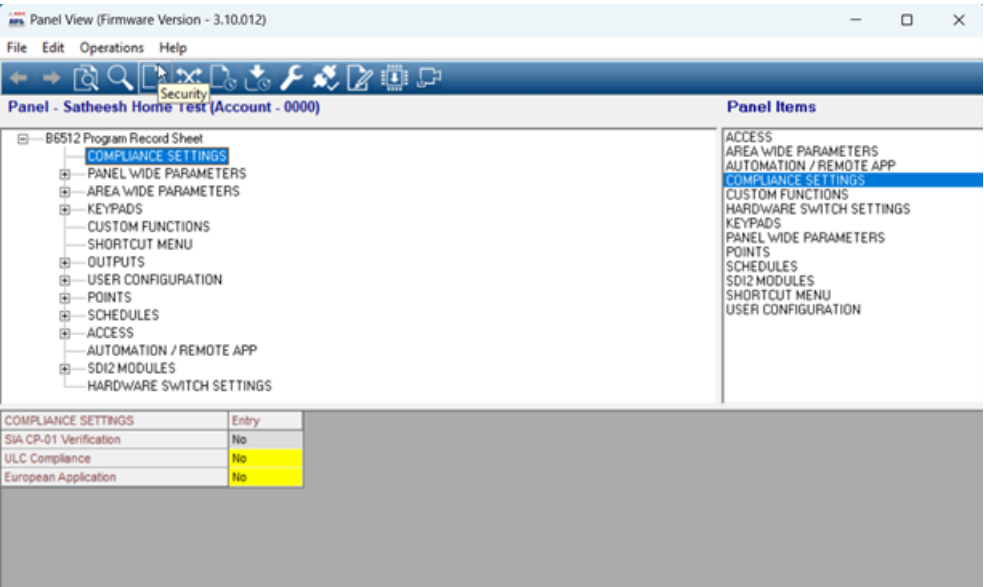
1. Launch RPS and connect to the control panel.

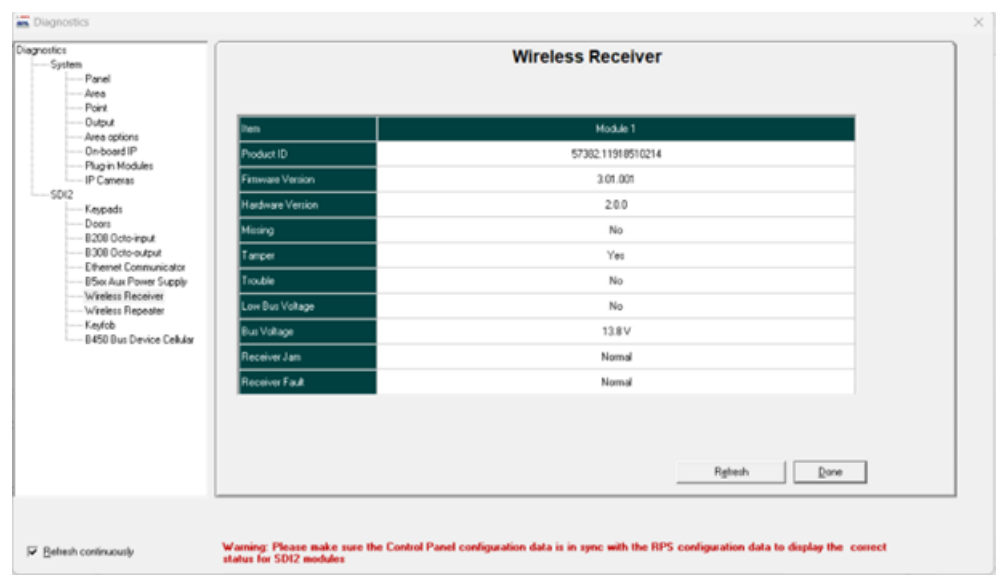
2. Open **Diagnostics** from the Toolbar menu.

3. Select **Wireless Receiver**.

The B810 Firmware and Hardware version are displayed on the Receiver Diagnostics Window.
